MISCELLANEOUS PAPER GL-92-11

## STABILITY OF OPEN-GRADED BASES UNDER WHEEL LOADS USING A MODEL TESTING APPROACH

DEPARTMENT OF THE ARMY

May 1992

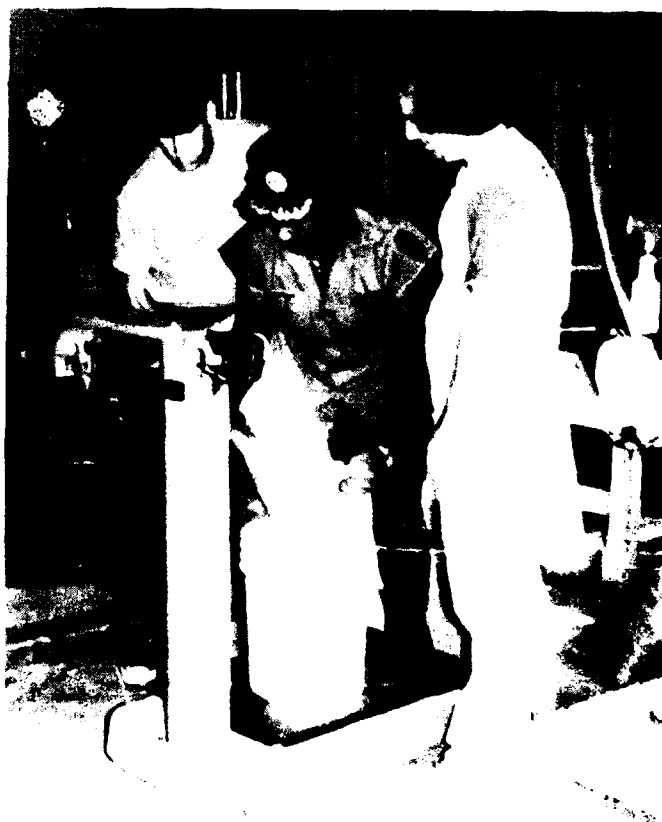
Photo 4. Weighing aggregates according  
to gradations

- c. The various sizes of aggregate used in blending the open-graded base were then weighed before mixing (Photo 4). Hand blending was then performed on the dry material to get a uniform mixture, followed by the addition of 5 percent water (Photos 5-9). The material was re-blended, placed in the top collar, and compacted. Again, the material was leveled, weighed, and samples taken to determine its water content. Photos 10-15 show the mixing procedure, a typical look of the final mixture, the placement of the material in the box, and the hand compaction. Photo 16 shows the weighing of the 600-lb load.
